# Corrosion & Materials

# Assessment of Material Selection for the CO<sub>2</sub> Absorption Process with Aqueous MEA Solution based on Results from Corrosion Monitoring at Technology Centre Mongstad

## Results from MEA amine plant corrosion processes at the CO<sub>2</sub> Technology Centre Mongstad

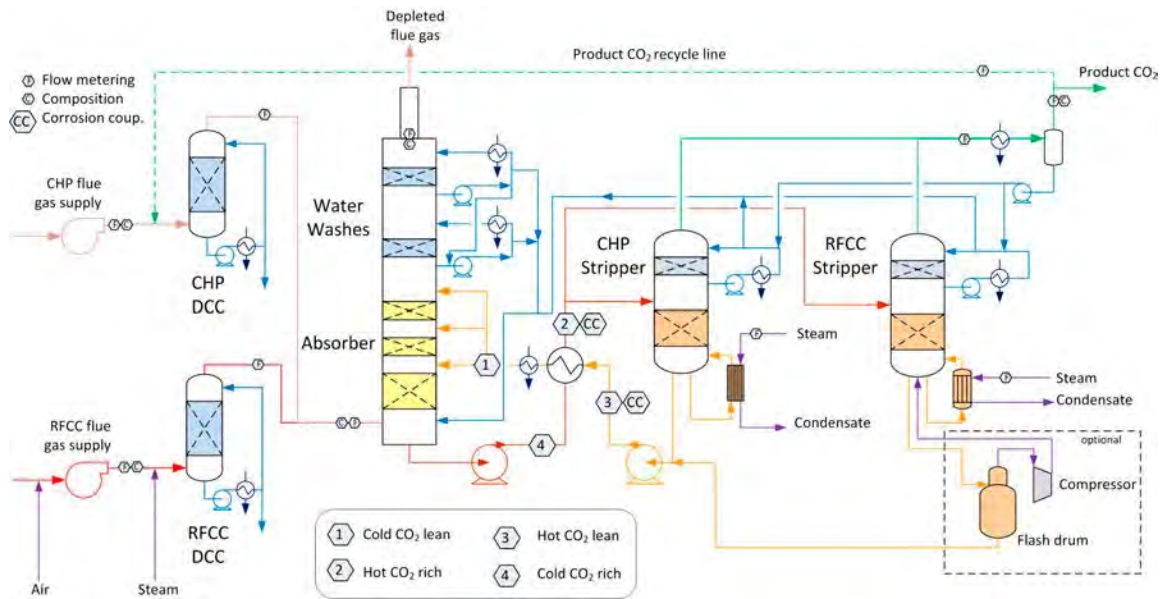
An illustration of the TCM DA Amine plant is shown in Figure 1. Flue gas containing CO<sub>2</sub> is contacted with the amine solvent in the absorber, leading CO<sub>2</sub> to react and be captured in the solvent. The rich solvent containing CO<sub>2</sub> is pre-heated by hot lean solvent in the lean/rich cross heat exchanger before it enters the stripper section. Additional heat is supplied by steam to the stripper reboiler in order to reverse the absorption reaction and release CO<sub>2</sub> from the solvent. The regenerated lean solvent leaving the stripper is cooled down in the lean/rich cross heat exchanger and lean cooler, before it is recirculated back to the absorber in order to capture CO<sub>2</sub> ones more. The depleted flue gas leaves the top of the absorber, while CO<sub>2</sub> is released to the atmosphere through the stripper section.

Figure 1: Illustration of TCM DA Amine plant and indication of rich and lean sections.

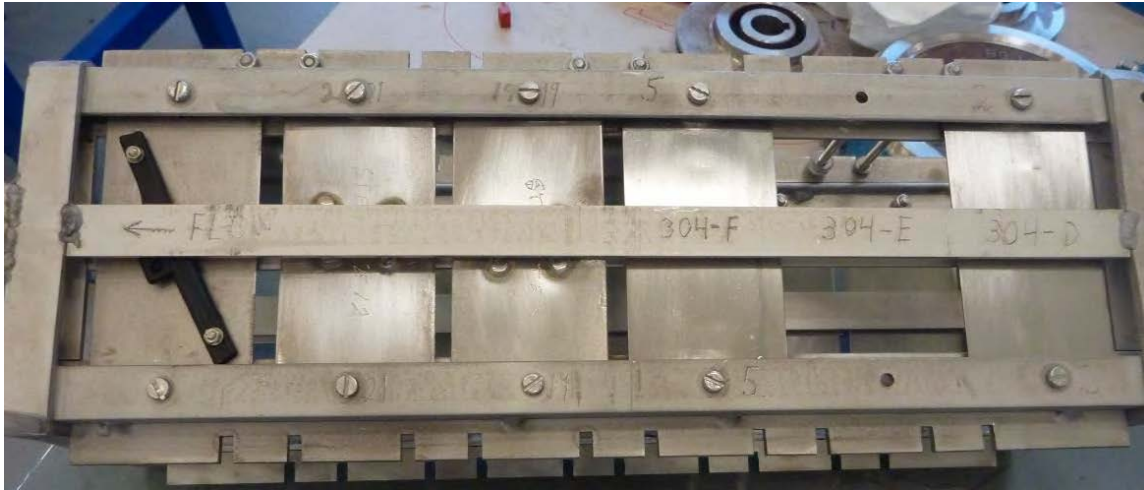
Figure 2: Illustration of coupons installed in the rack. Flow direction from right to left.

The corrosion racks are of alloy 316L and are placed longitudinally in the pipe. This means that some specimens are placed at the top side of the piping, while others are located at the bottom of the pipe. Bent coupons are placed at

Table 5. Indicate coupon position in the lean rack, with number labelling. Flow direction from right to left.

Location	Materials					
Top side	EPDM (29)	Stellite 12 (21)	Stellite 6 (19)	SS304L (5)	empty	SS304L (2)
Bottom side	CS S235 (12)	Inconel 600 (13)	CS S235 (1)	SS316L (6)	Duplex (17)	SS316L (4)
Side of rack	SS304L (25)		SS316L (23)		CS S235 (27)

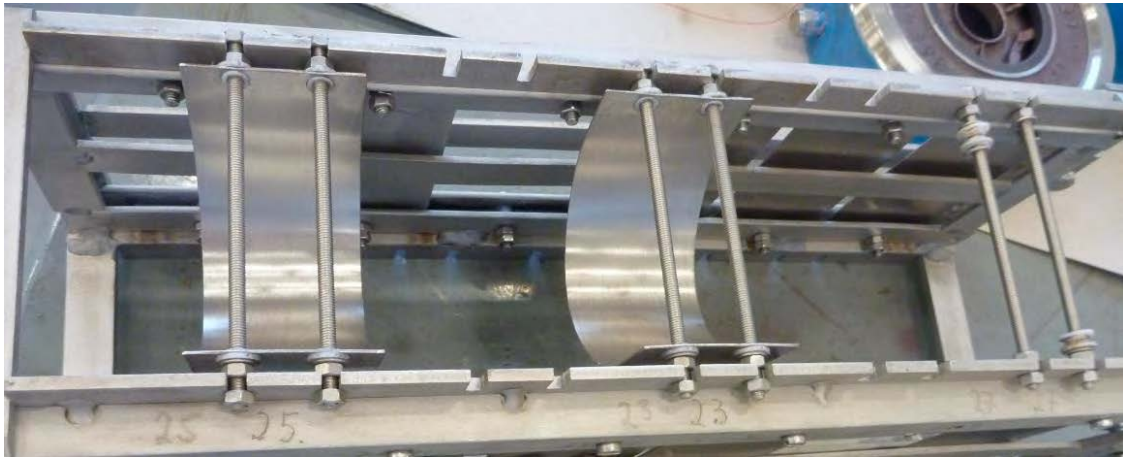
Figure 3: Illustration of bent coupons installed in the rack. Flow direction from right to left.

the side of the rack. To ensure that there is no contact between each coupon and the rack, PTFE insulators are mounted between the two materials. Table 5 and Table 6 illustrates where in the rack each coupon is installed.

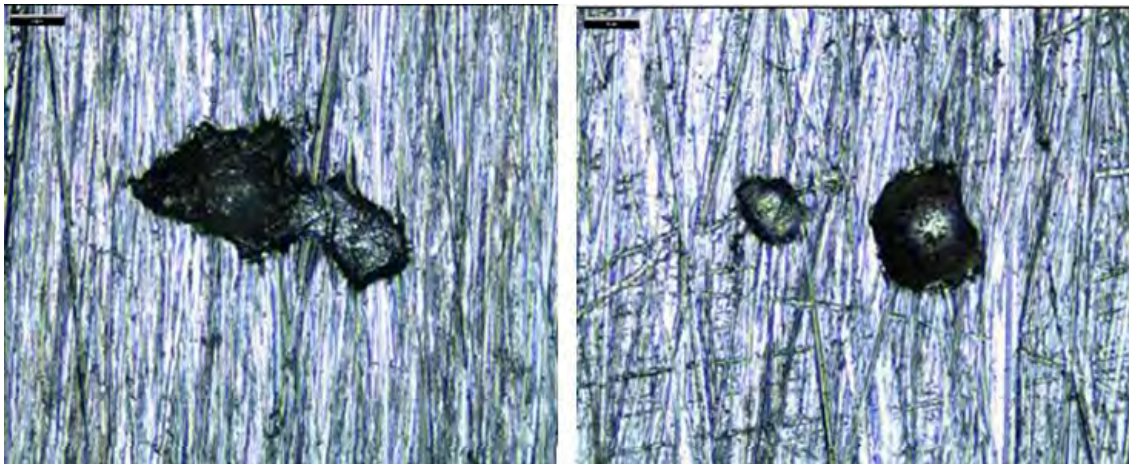
All the coupons in alloy 316L had corrosion rate below 0.1 mm/year. No pitting was observed on 316L coupons exposed in lean solvent, while three pits were found on each of the 316L coupons exposed to the rich solvent. Figure 4 shows pictures of two pits found on these coupons. The maximum pitting depth was 51  $\mu\text{m}$ , corresponding to 0.15 mm/year.

Figure 4. Pictures of pitting found on SS 316L coupon. Left picture illustrates pitting depth 51  $\mu\text{m}$  at magnification 400x(coupon no. 8), while right illustrates depth 36  $\mu\text{m}$  at magnification 160x(coupon no. 7). No similar pitting was found on the unexposed reference coupon..

There were some mechanical damages on the coupons which made it difficult to analyze pitting corrosion. A few pits were found on the 316L coupons while no pitting was found on SS304L. SS316L is placed against the bottom while SS304L is placed against the top of the pipe coil. In periods without solvent circulation it may have been some deposits that have covered the surface of SS316L which can increase the corrosion attacks. However, the lean coupons have not been affected by the shutdown periods.

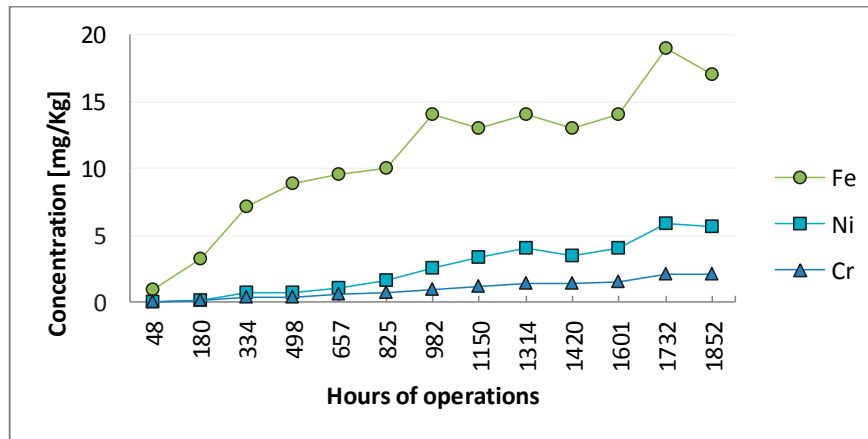
Figure 5 illustrates the ion concentration of metals in lean amine solvent. The aim of monitoring the metals in the solvent is to follow the increase of the metal ions. If a rapid increase would occur, inspection and evaluation of the cause(s) would have to be performed. In an amine plant some increase of metal ions is acceptable. Rennie (2006) informs that corrosion is typically worse at locations where the acid gases are flashed off, for example the regenerator reboiler [12]. In the reboiler and stripper section of the amine plant at TCM DA, fouling in the equipment and piping system is observed. This may be related to the boiling off of the solvent and the temperature at this location. The increase of metal ions might come from this hot section of the plant. However, internals within the absorber are manufactured in SS 316L, and might be affected by the process environment in the absorber. The flue gas from the CHP plant does not consist of considerable amount of metals. RFCC gas do contain a higher level of metals, but even with the mixed RFCC and CHP gas the metal ion concentration do not seem to have rapidly increased during the mixing period. This excludes that most of the metal ions measured in the solvent could originate from the flue gas during this MEA campaign.

Figure 5: Metal ion concentration in lean solution. X-axis provides time of solvent analysis.

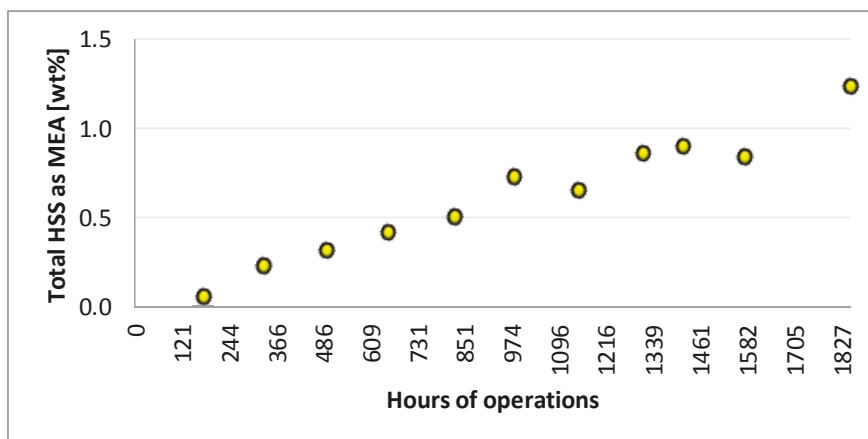
HSS are reported as the wt% of the equivalent amount of amine. This means if HSS concentration were 1 mole/kg (eq/Kg) of solution, it will be 6.1 wt% as MEA. Figure 6 illustrates the HSS wt% measured by titration during the campaign. Approximately 1.25 wt% HSS were measured at the end of the campaign, and the increase was close to linear.

Figure 6. Heat stable salts measured by titration. X-axis provides time of solvent analysis.
